# MONTANA DEPARTMENT OF ENVIRONMENTAL QUALITY Permitting and Compliance Division Waste & Underground Tank Management Bureau

# FIELD INVESTIGATION REPORT

SITE: Asarco - East Helena Facility

**PURPOSE:** Compliance Evaluation Inspection

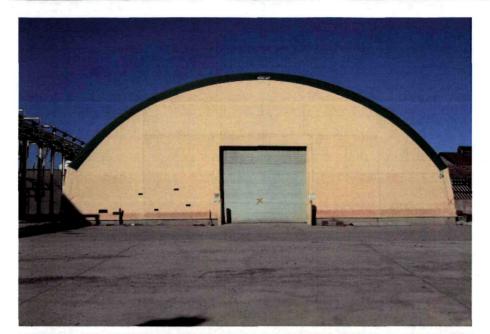
PHOTO #: ASARCO\_08213-001 SUBJECT: Compliance Inspection LOCATION: East Helena, MT.

Looking south at the Ringling Building and vehicle access door.

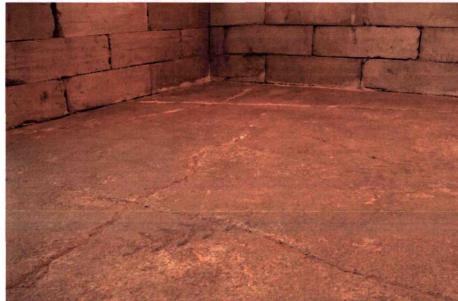
PHOTO #: ASARCO\_08213-002 DATE: July 31, 2008

Inside the Ringling Building, the floor and concrete lego blocks, making up the inside of the waste containment system, had been cleaned, swept, vacuumed and powerwashed.

The lego block walls were being removed from the building at the time of the inspection and the floor was being swept and cleaned again.

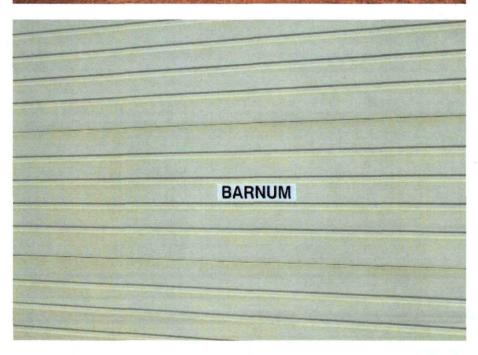
PHOTO #: ASARCO\_08213-003 DATE: July 31, 2008

Looking west at the east access door to the Barnum Building.

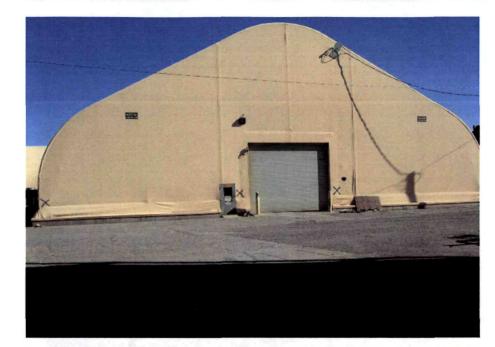
PHOTO #: ASARCO\_08213-004

Looking west at the Barnum Building.

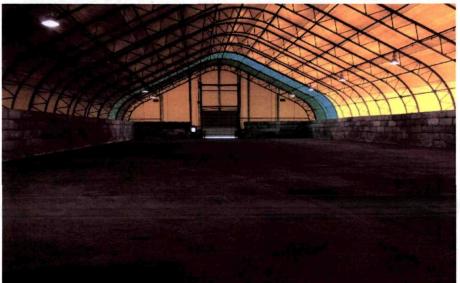
PHOTO #: ASARCO\_08213-005

In addition, it appears that the Barnum and Bailey Coverall Buildings failed to meet closure and post-closure care requirements as per 40 CFR 265.1102 until the lego block walls are removed from these two buildings due to waste material that remains embedded in the cracks of the lego walls.

Inside the Barnum Building, the floor and concrete lego block walls, making up the inside of the waste containment system, had been cleaned, swept, vacuumed and power-washed.

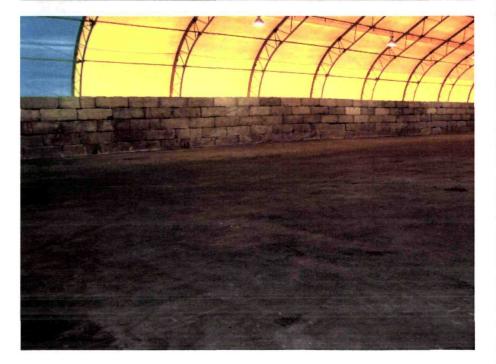
PHOTO #: ASARCO\_08213-006

Another view of the north side lego block wall inside the Barnum Building. The height of the wall is approximately 10-feet.

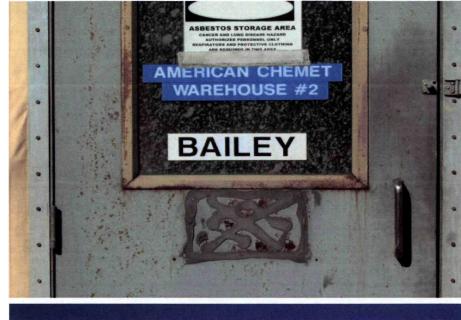
PHOTO #: ASARCO\_08213-007 DATE: July 31, 2008

Looking south at the north man-door leading into the

Bailey Building.

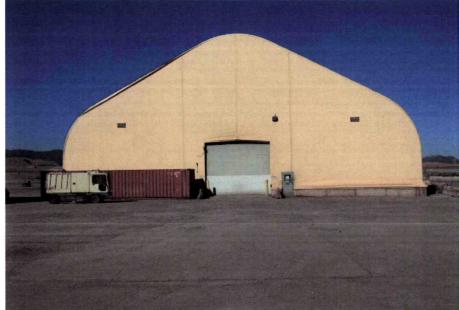
PHOTO #: ASARCO\_08213-008

Looking south at the Bailey Building.

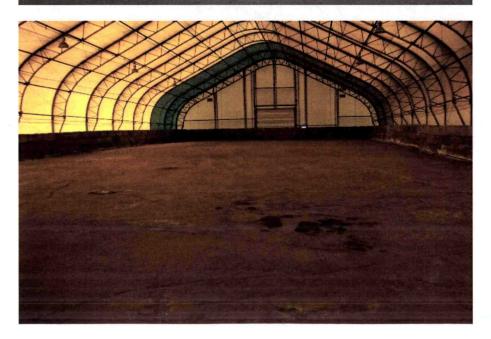
PHOTO #: ASARCO\_08213-009 PHOTOGRAPHER: Iver Johnson PHOTOGRAPHER (int.)

Inside the Bailey Building, the floor and concrete lego block wall, making up the inside of the waste containment system, had been cleaned, swept, vacuumed and power-washed.

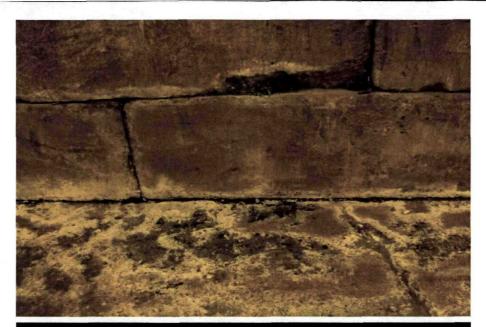
PHOTO #: ASARCO\_08213-010 DATE: July 31, 2008

I noted that some waste had fallen onto the floor from the cracks in the lego block wall in the Bailey Coverall Building since the floor was cleaned. The waste appeared to contain copper as the staining on the floor was blue and green in color. (See photos 007 through 010 in the attached photolog).

This photo shows some remaining waste that had fallen out onto the floor from the cracks in the lego block wall since the floor was cleaned. The waste appeared to contain copper as the staining on the floor was blue and green in color.

**ADDENDUM:** On August 20, 2008, Mr. Nickel told me in a telephone conversation that all the lego blocks have been removed from the Ringling Coverall Building. The lego block waste on the floor in the Bailey Coverall Building has been collected and the floor cleaned once again.

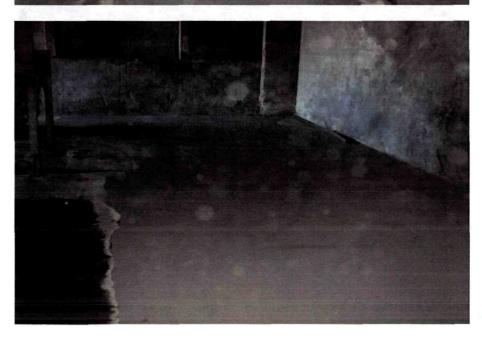
PHOTO #: ASARCO\_08213-012

This photo was also taken inside the Concentrate Storage Handling Building (CSHB). Looking into the I-Bin, all the waste previously stored in this bin had been removed and disposed of in the CAMU except for a small amount of waste collected by the street sweeper.

Note: The I-Bin had been swept, but, not vacuumed or power-washed in anticipation of storing additional waste in the near future.

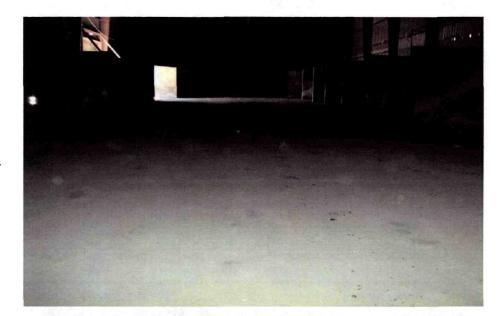
PHOTO #: ASARCO\_08213-013

This photo was taken inside the Direct Smelt Building. Asbestos waste previously stored in this building had been removed and disposed of in the CAMU.

Note: The Direct Smelt Building floor has not been swept, vacuumed or power-washed.

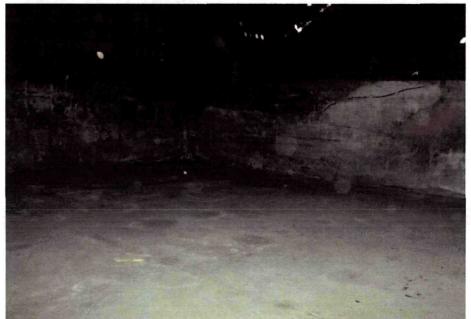
PHOTO #: ASARCO\_08213-014

Another view inside the Direct Smelt Building where cardboard containers of asbestos waste was previously stored.

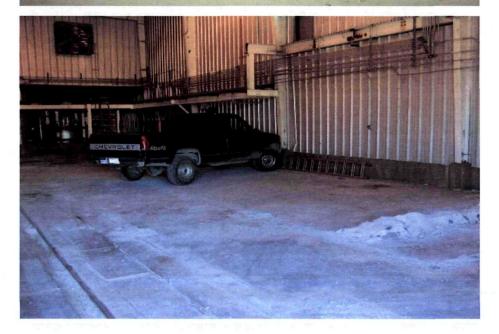
PHOTO #: ASARCO\_08213-015 DATE: July 31, 2008

This photo shows the inside of the Sodium Metal Building after the rail tank car and heating coils were removed, cut-up and sent off for metal recycling.

The building is now used to house Asarco facility and personal vehicles.
